Navajo Abandoned Uranium Mine

Site Screen Report

Rocky Flats No. 2 AUM Site

March 2010

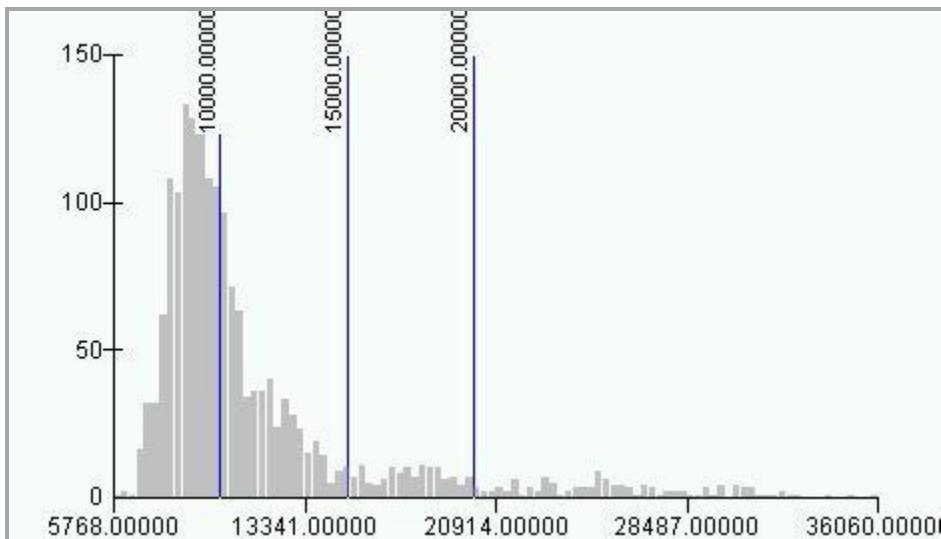
Distribution Chart and Statistics:

The following chart and statistics were generated by ESRI ArcGIS 9.3.1, and show the general distribution of the site gamma radiation measurements. The horizontal X axis represents the gamma radiation reading levels in cpm (lowest levels to the left). The vertical Y axis represents the frequency of each gamma radiation level.

Count:	1755
Minimum:	5768.000000
Maximum:	36060.000000
Sum:	20057502.000000
Mean:	11428.77607
Median:	9775.00000
Standard Deviation:	4778.16191

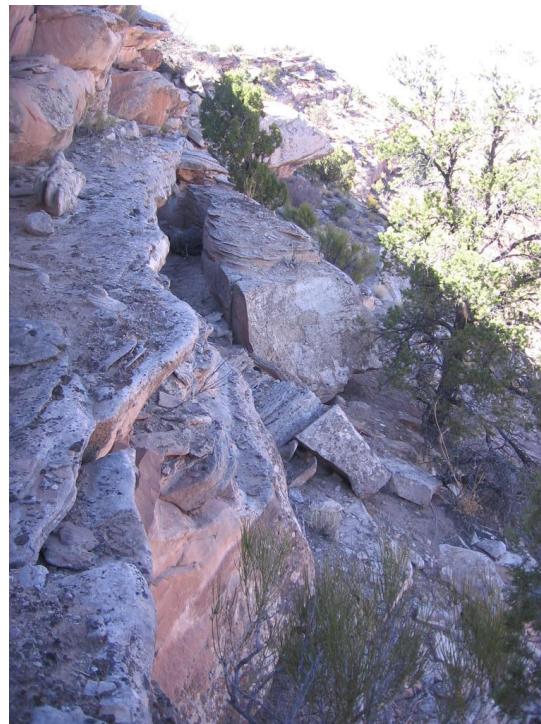
Photo 1. Stone hogan ruins

Photo 2. Mine site

Photo 3. Waste pile

Photo 4. Waste rock and sealed adit location

Photo 5. Waste rock

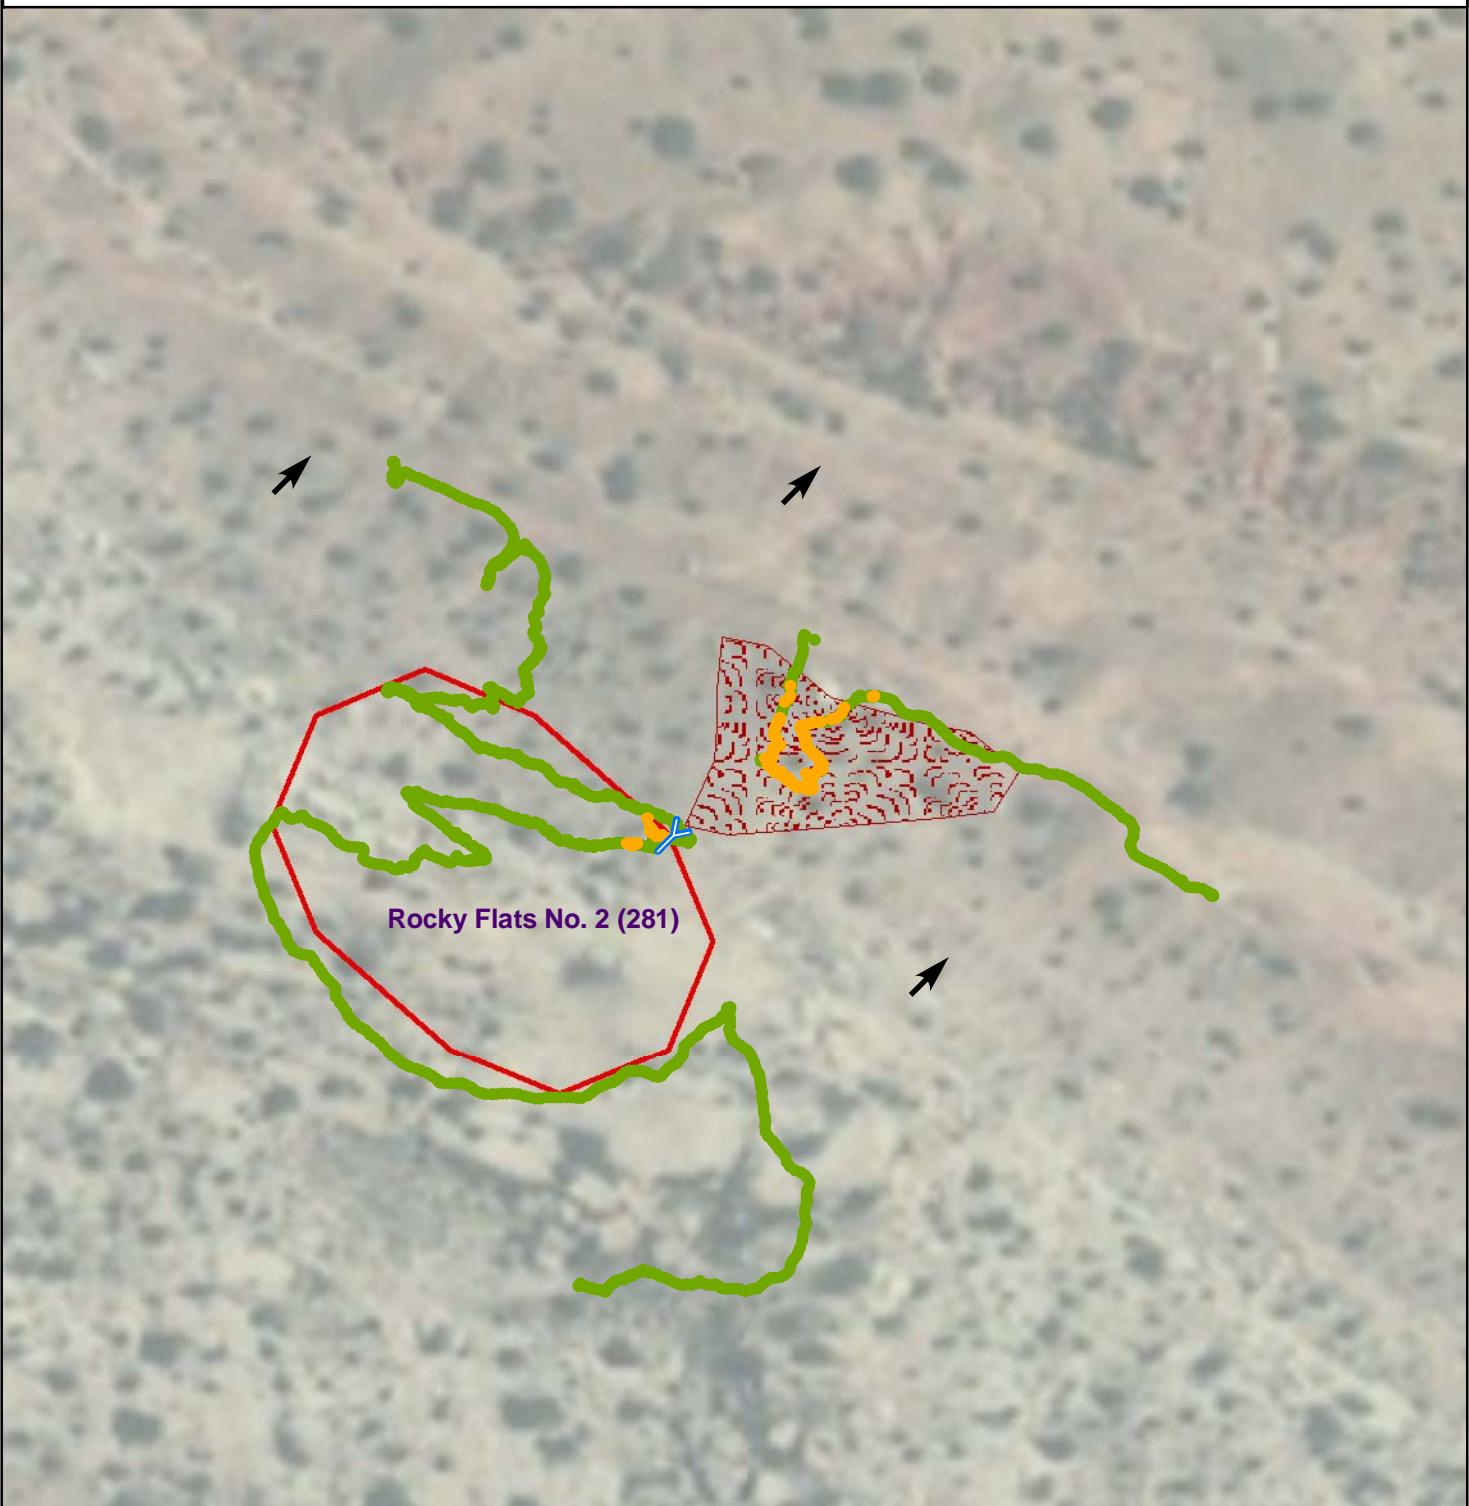
Figure 1 - Gamma Radiation Measurements, Above Two Times Background
Rocky Flats No. 2 (281)
Beclabito Chapter, Navajo Nation, Arizona

A total of 1,755 gamma radiation measurements were collected from the mine site, ranging from 5,768 cpm to 36,060 cpm. Measurements in the vicinity of the waste debris were found at levels of approximately 35,000 cpm and at the entrance of the adit of approximately 14,000 cpm. The measurements are represented in Figures 1 and 2.
